**Flood Control Project Maintenance
Levee Inspections**

Fall 2011 Levee Maintenance Deficiency Summary Report

Reclamation District No. 0554 Walnut Grove

Levee Inspection Report By Mile - Fall 2011

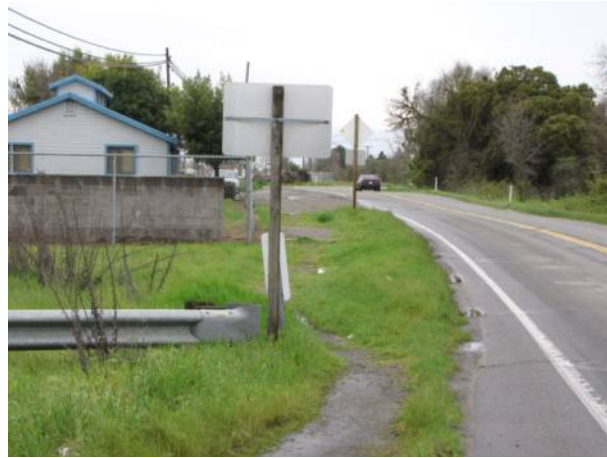
phillips_f_20110929_167.jpg

Levee Mile Report Line	1
Start Levee Mile	0.00
End Levee Mile	0.00
Location	Land Side
Category	Earthen Levee
Item	Vegetation

Standing at the end of RD 369 landward looking downstream at levee mile 0.00 of RD554, this is actually where the unit begins. Photo was taken 3-16-2011

LMR No.	Levee Mile		Category	Item	Location *	Rating **	Action/Comment	GPS Latitude/Longitude		Issue No. Photo
	Start	End						Start	End	
1	0.00	0.00	Earthen Levee	Vegetation	LS	A	Remove the wild growth other than native grasses from the levee slopes.	38.249538 ° -121.509960 °	38.249538 ° -121.509960 °	1 Y
2	0.18	0.29	Supplemental	USACE Erosion Survey	WS	M	Inspector Comments: 2009 - Tension cracks on road on top of levee. Erosion into the levee slope and mass failure. 2011: No observed change. Difficult to see with the vegetation. [2011 Site ID: SAC_27-0_L]	38.246222 ° -121.510878 °	38.245017 ° -121.511740 °	2 Y
3	0.77	0.85	Earthen Levee	Vegetation	WS	C	Remove the wild growth other than native grasses from the levee slopes.	38.239876 ° -121.516113 °	38.238902 ° -121.516113 °	10
4	0.97	0.97	Earthen Levee	Encroachments	WS	PO	Buildings	38.237108 ° -121.516743 °	38.237108 ° -121.516743 °	6
5	0.98	0.99	Earthen Levee	Encroachments	WS	C	Fences	38.237100 ° -121.516730 °	38.236867 ° -121.516868 °	5

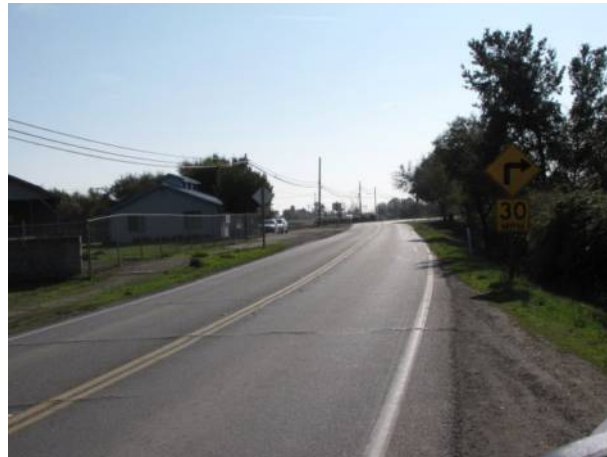
phillips_f_20111207_105.jpg

Levee Mile Report Line	1
Start Levee Mile	0.00
End Levee Mile	0.00
Location	Land Side
Category	Earthen Levee
Item	Vegetation

Standing waterward at the end of RD 369 looking downstream at levee mile 0.00 RD 554. Photo taken 10-20-2011.

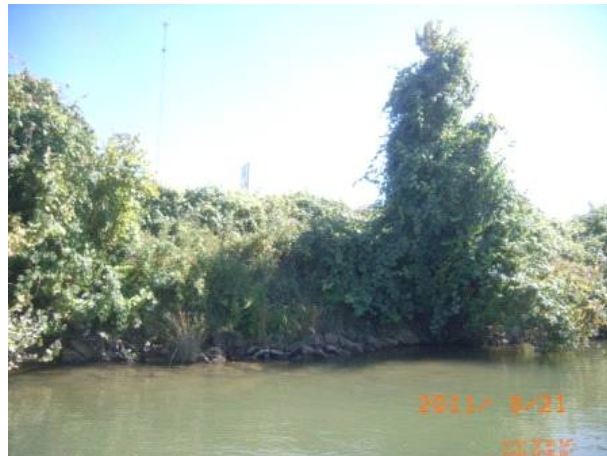
USACE 2011 Photo #1

Levee Mile Report Line	2
Start Levee Mile	0.18
End Levee Mile	0.29
Location	Water Side
Category	Supplemental
Item	USACE Erosion Survey

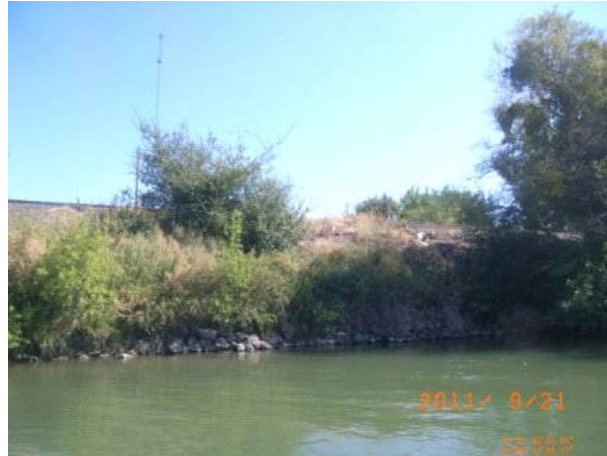
Levee Mile Report Line	2
Start Levee Mile	0.18
End Levee Mile	0.29
Location	Water Side
Category	Supplemental
Item	USACE Erosion Survey
USACE 2011 Photo #2	
USACE2011_SAC_27-0_L_2.jpg
